AJ Mac Homes LLC

Property Inspection Report

1 Sample St, Dothan, AL 36305 Inspection prepared for: John Sample & Sue Sample Date of Inspection: 7/20/2015 Time: 3:00 PM Age of Home: 11 Size: 1720 Weather: Sunny

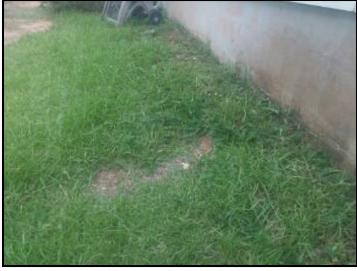
Water from roof is not draining properly from foundation. Gutters are recommended to keep water away from foundation.

Storm water not draining properly from foundation.

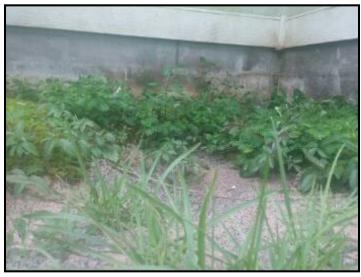
Another Valley in the roof

Water runoff is too close to foundation. Gutters are recommended

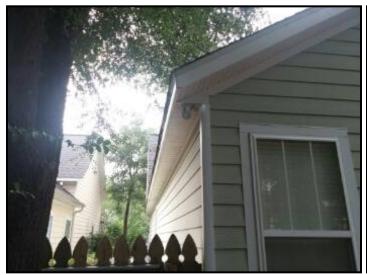
Trim limbs away from roof. Limbs close to roof can cause damage to the roof and also the shingles will not dry properly.

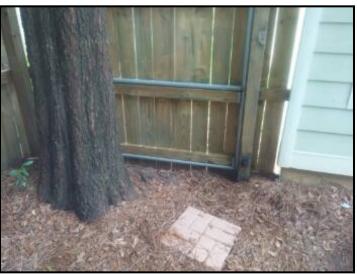
Tree too close to house. Roots could cause problems with the foundation.

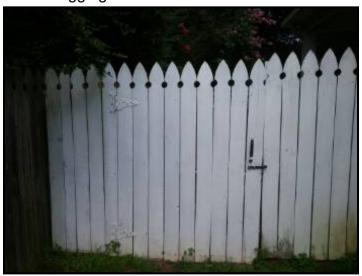
- Fences and gates are NOT INCLUDED as part of a home inspection. Recommend confirming that all fences and gates are in serviceable condition before the close of escrow.
- Damaged gate observed.
- Gate is sagging.

Gate Hangs

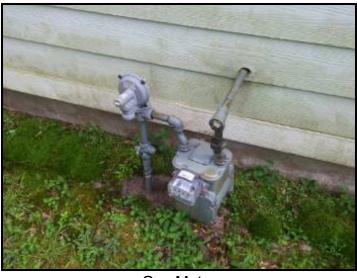
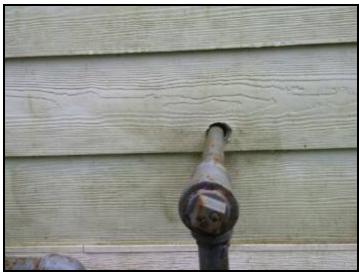
Gas Meter

• Gas Inlet should be caulked to prevent water and insects from entering.

Gas entrance needs caulking

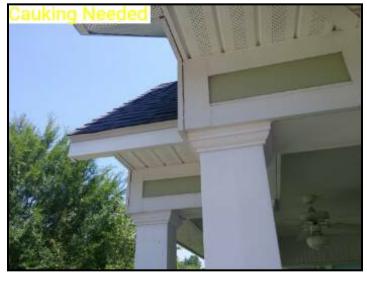
Cauking is need here.

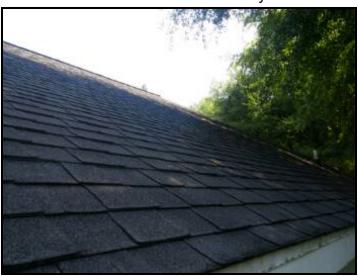
Limbs too close to roof.

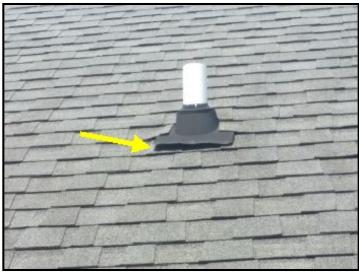
- Asphalt shingles noted.
 Observations:
 Some shingles curling.
 Note that experts recommend that any roof over 10 years old receive a roof certification by a local roofing specialist.

Nail has come loose

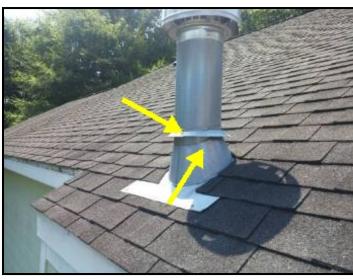
Caulking is needed, Water is coming through

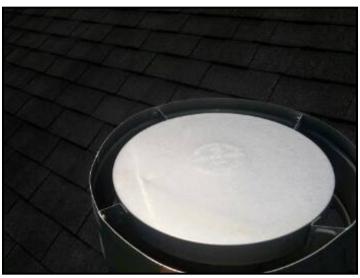
Chimney Cap is in good condition.

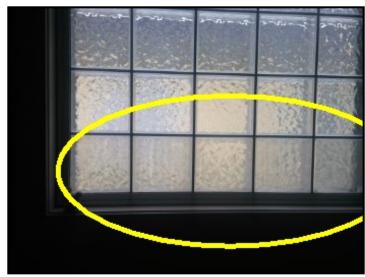
Window in Master Bedroom has condensation on bottom row of window blocks

Condensation
